SILSDEN FLOODS

26 December 2015

A report on where the water came from, where it went and the damage caused.

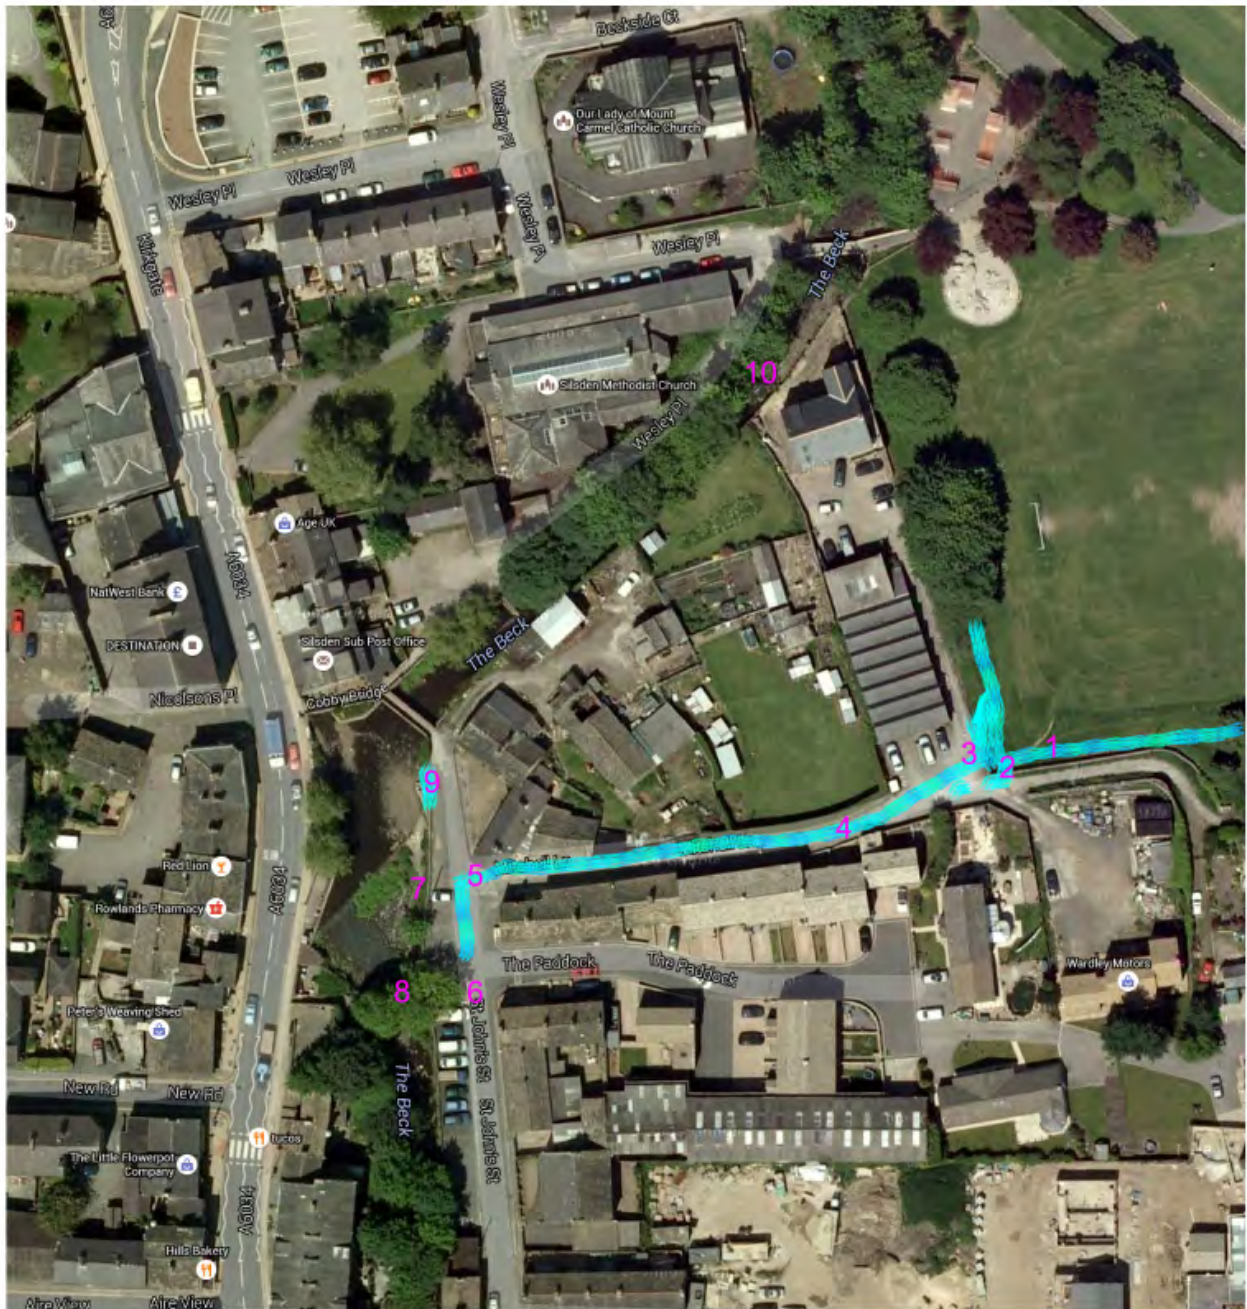
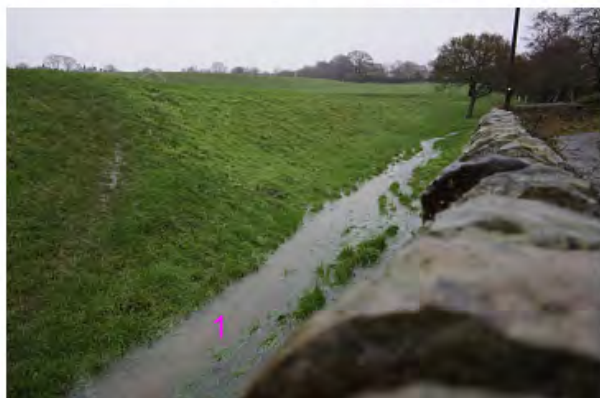
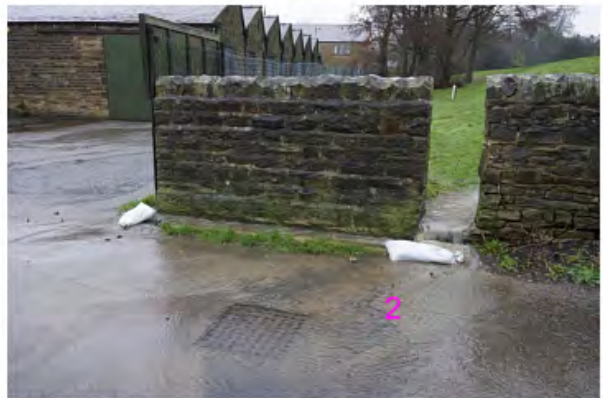
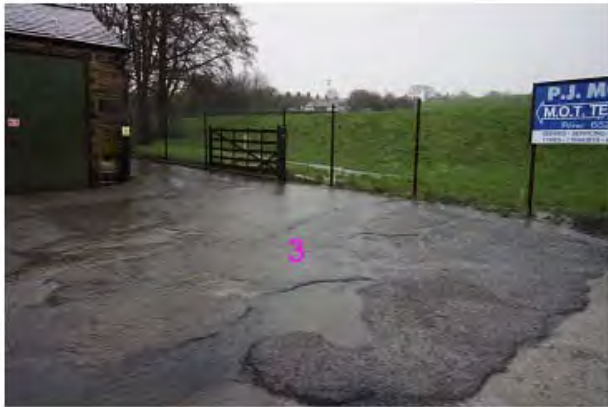
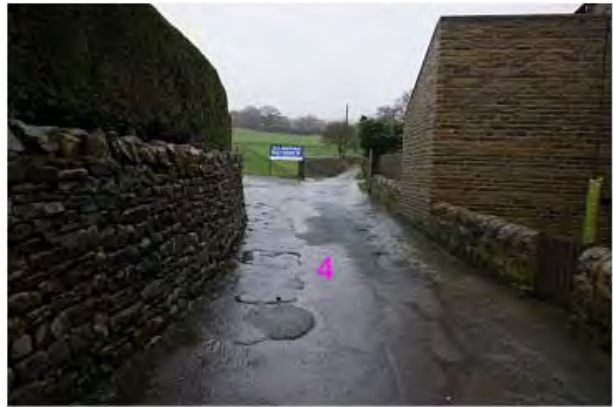
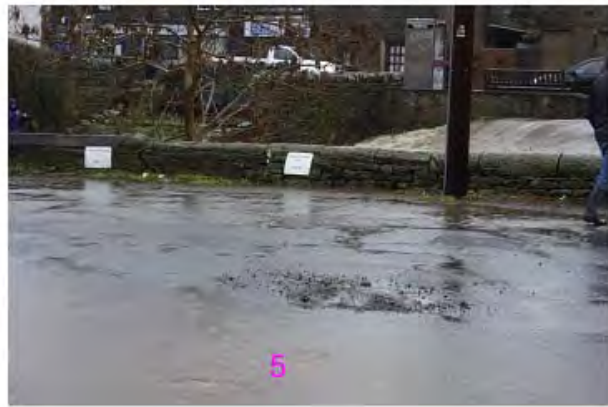
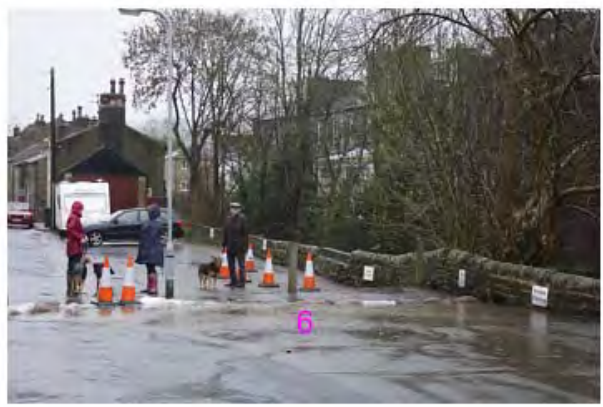
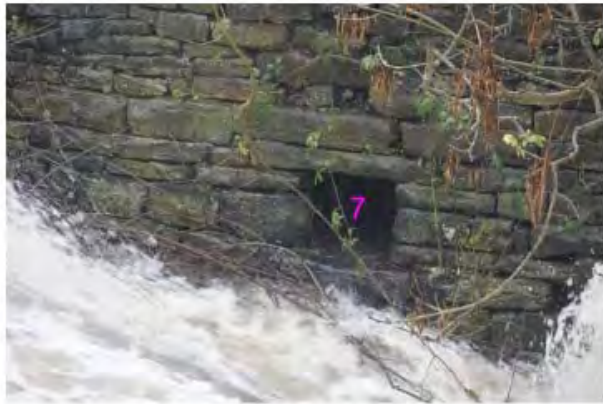
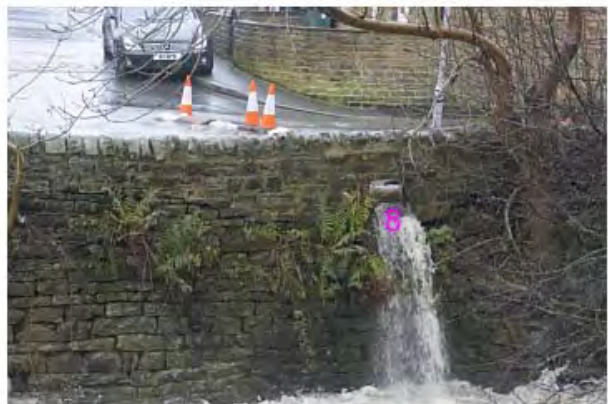
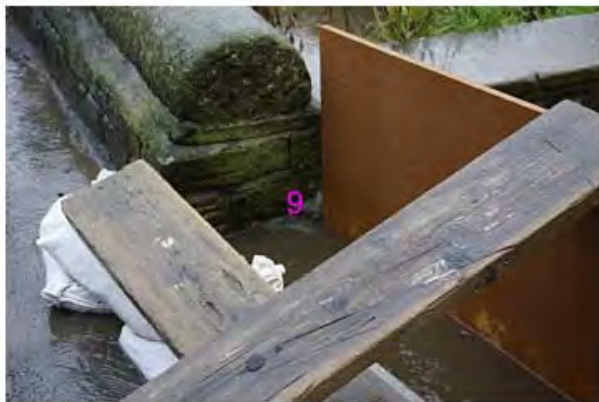
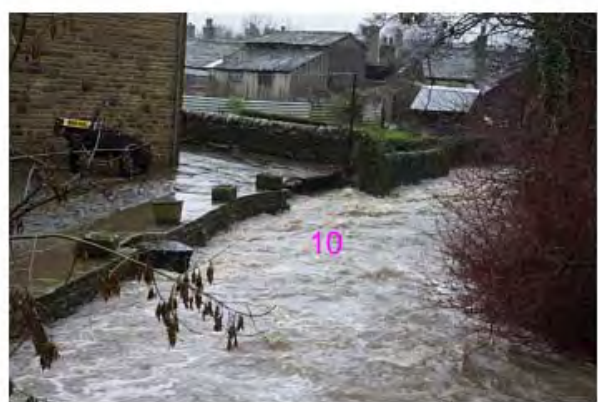
St John Street - Mitchell Lane, Floods 26 December 2015

Most of the water in St Johns Street was runoff from the park. The water was pouring through the gap in the park wall at the top of Mitchell Lane, and only because of the strategically placed sandbags did it go into the two adjacent drains – this stopped a lot of water from going down Mitchell Lane. However, water also escaped from the park through the fence and this water ended up in St Johns Street.

The large storm drain (at the bottom of Mitchell Lane) is completely blocked, the water could be seen bubbling out of it. The question should be asked as to where the water going to from the drains further up Mitchell Lane?

Not being able to get to the beck via the storm drain, the water went down St Johns Street. However, this time it was diverted with sandbags through a hole in the beck wall. This was quite a lot of water, please see the pictures.

Had this been finished it would have been used. The water was effectively kept in the beck by boards and sandbags. At the time I photographed the floodgate the water level was about 8cm above the sill of the ford and I think the water level at the time was going down. Whether such a large barrier is needed for this job is debatable, but a barrier is required so that local residents can close this source of flooding easily. **The wall between the top of the weir and the ford is porous**

- Build a small wall around the two drains (by the gap in the park wall) to direct runoff water into the drains.
- Make the sandbag water diversion across St Johns St more permanent until....
- The large storm-drain at the end of Mitchell Lane / St John Street is cleared.

The runoff water from the park should not escape from the park. A large holding tank should be built in the corner of the park to prevent this run off.

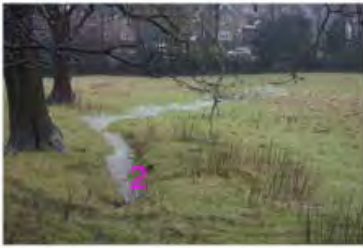
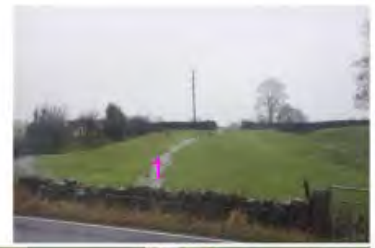
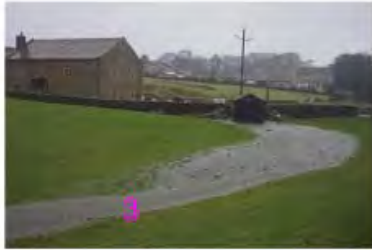
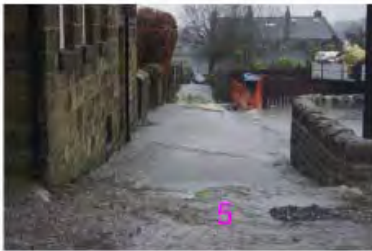
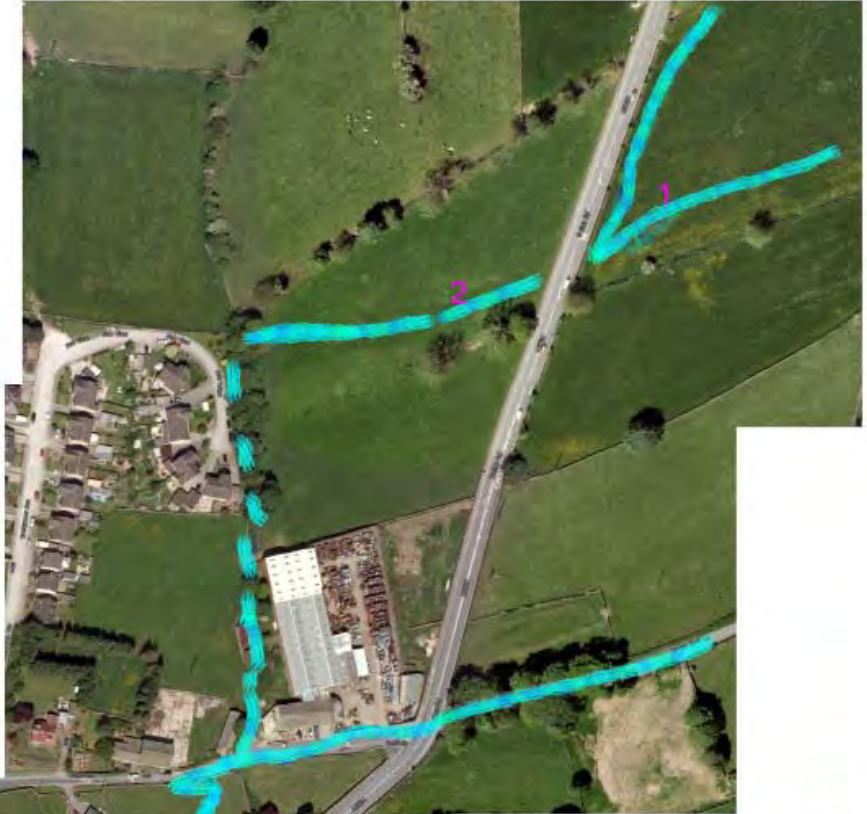
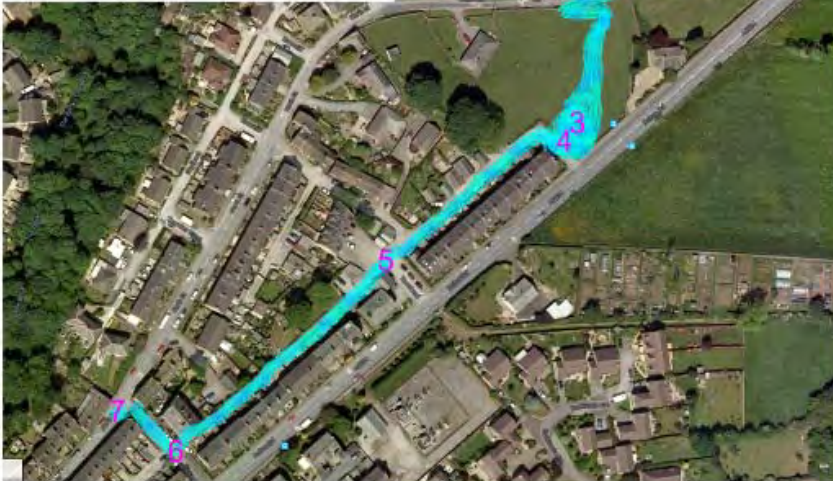
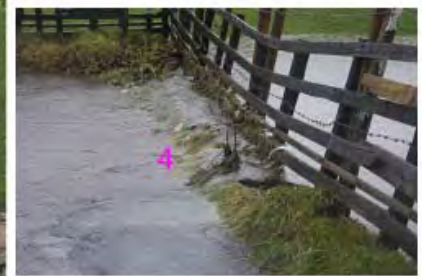
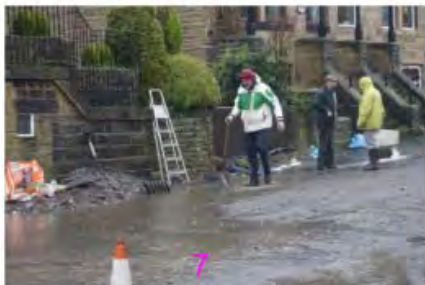
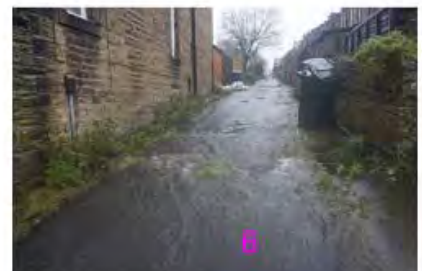
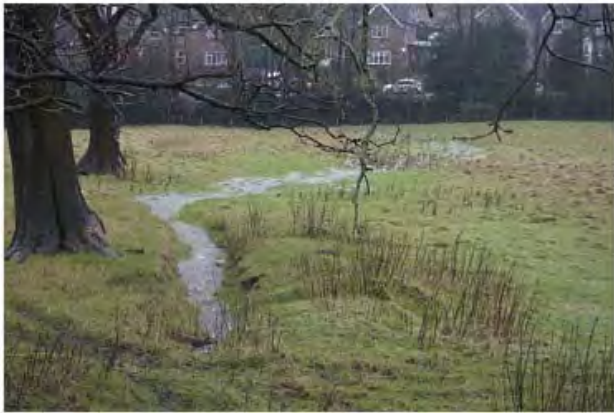
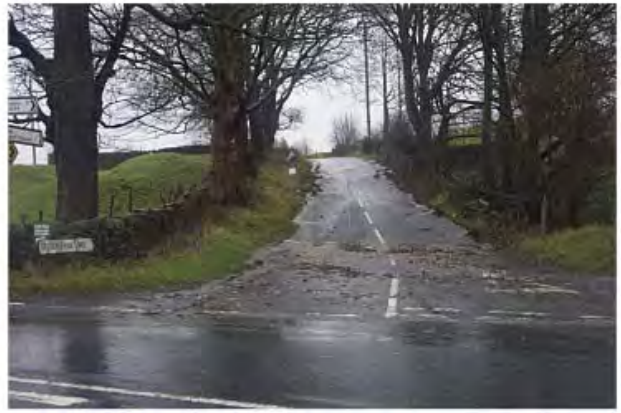
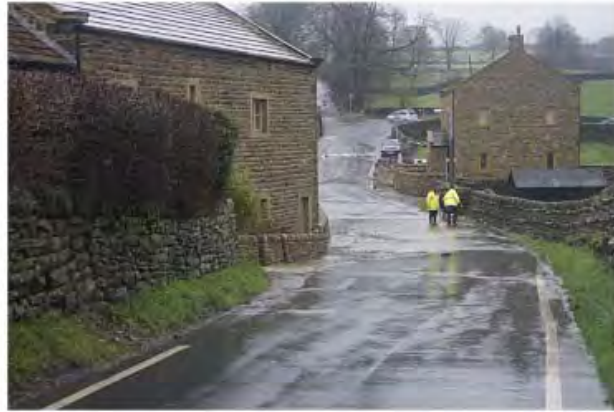
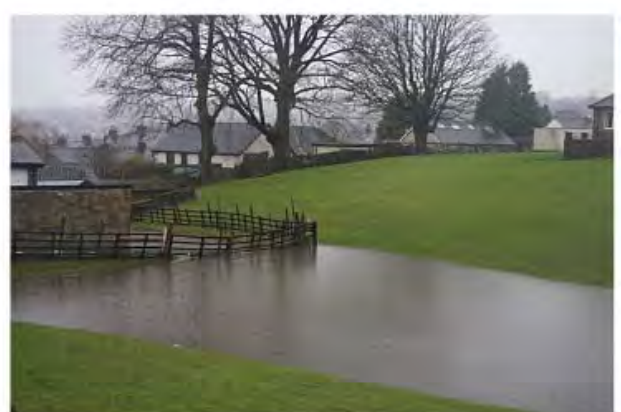
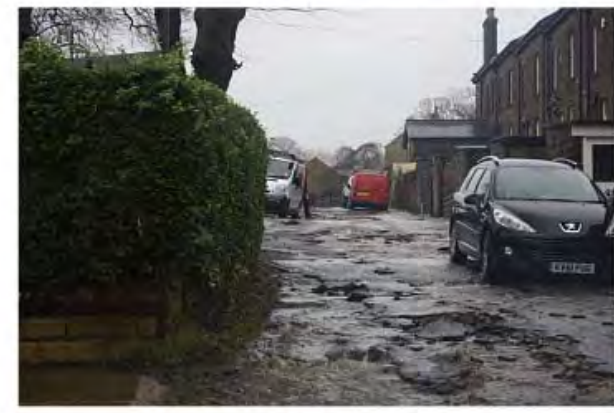
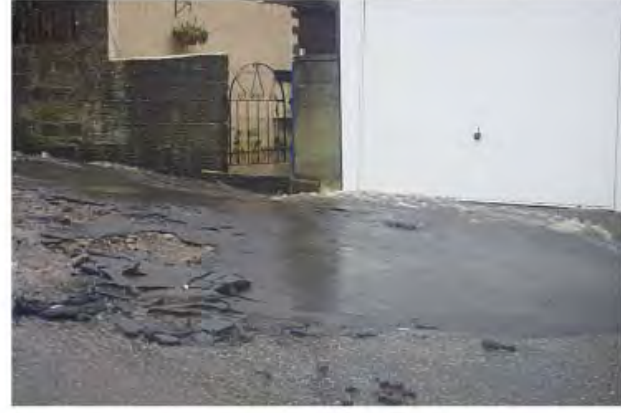
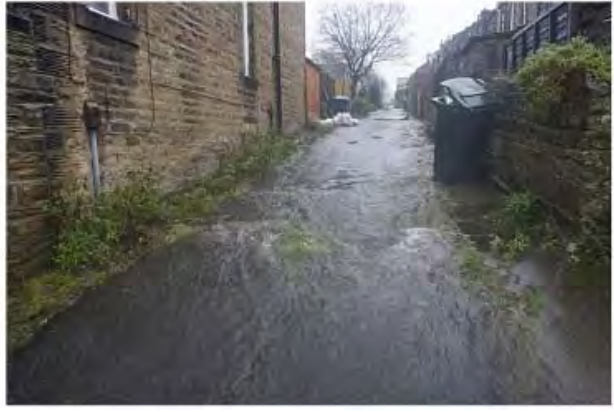
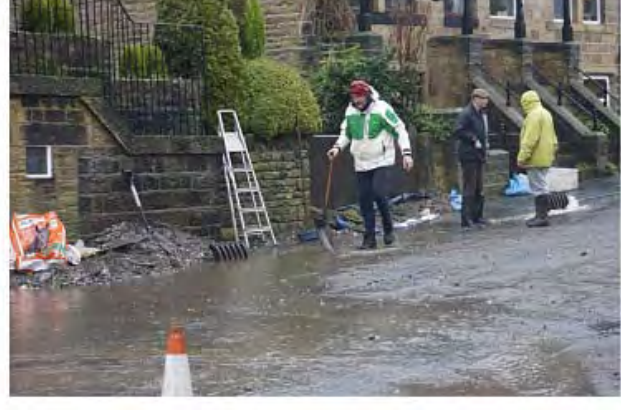
Pickard Lane Floods
Boxing Day 2015

This occurred because of surface water which originated above Bolton Road. Please see the pictures.

Improve the drainage ?????

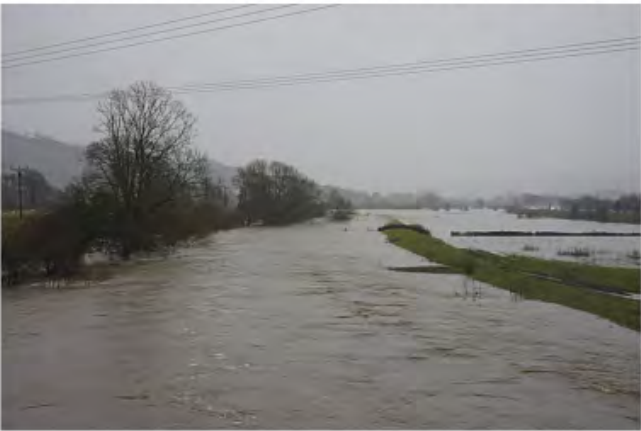
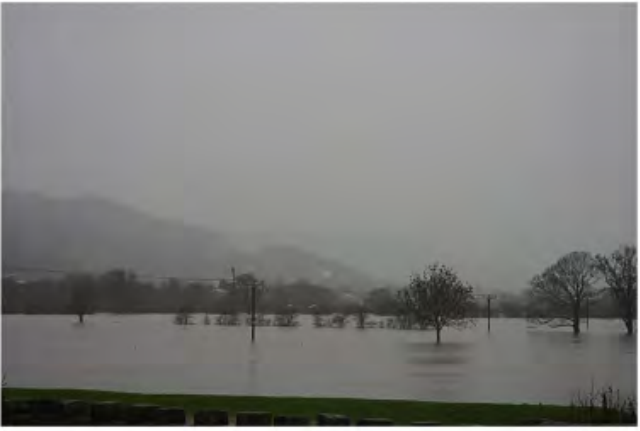
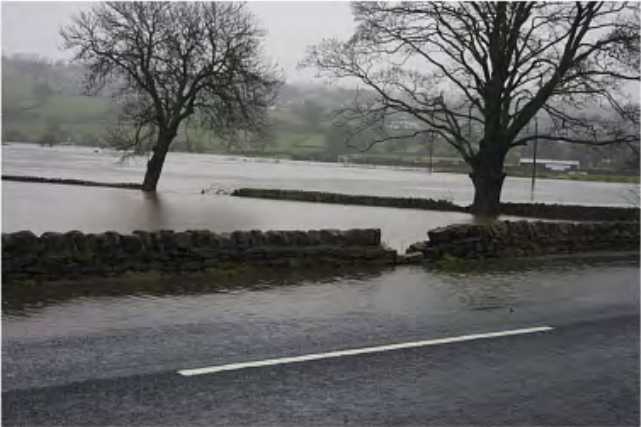
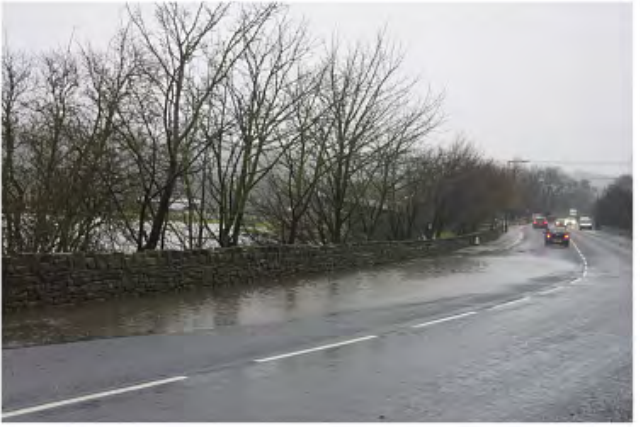
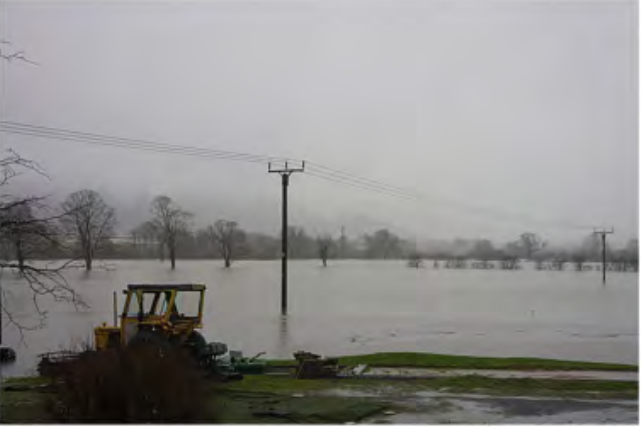
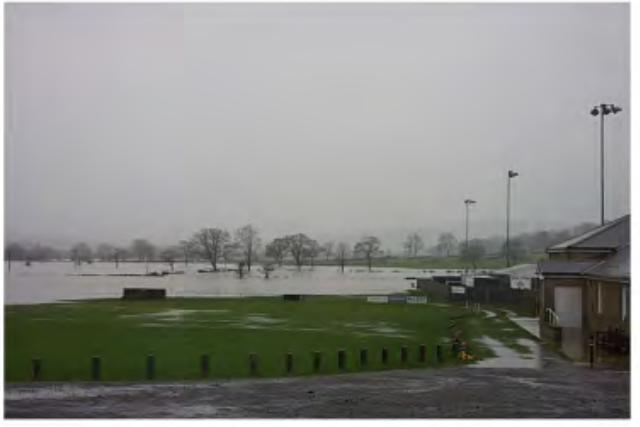
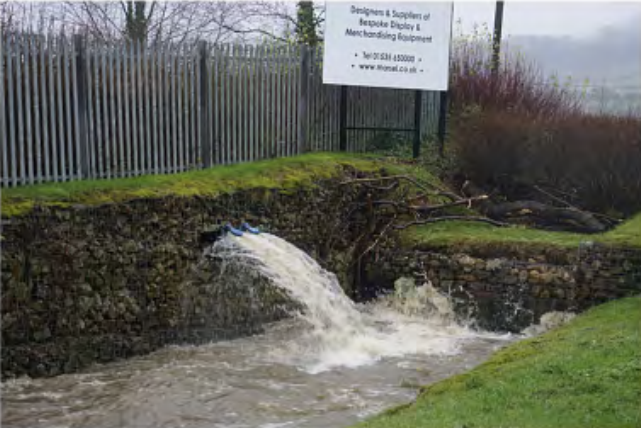
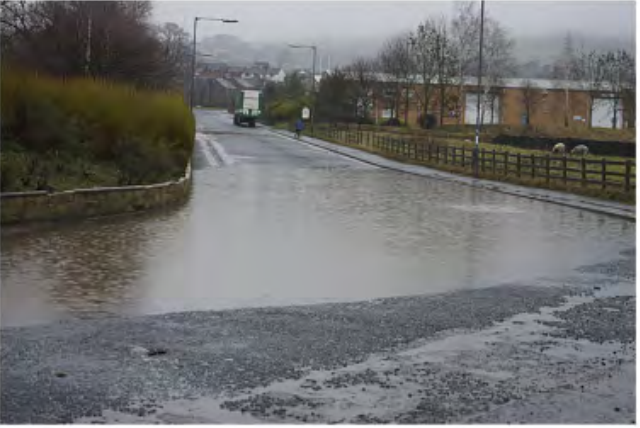
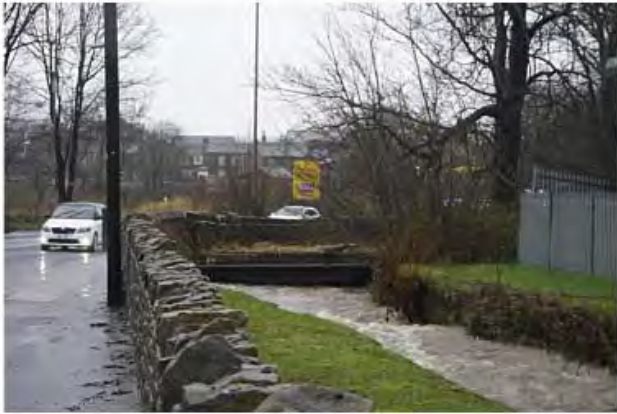
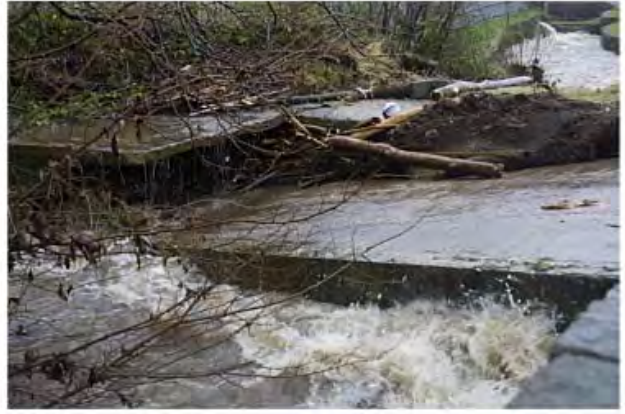
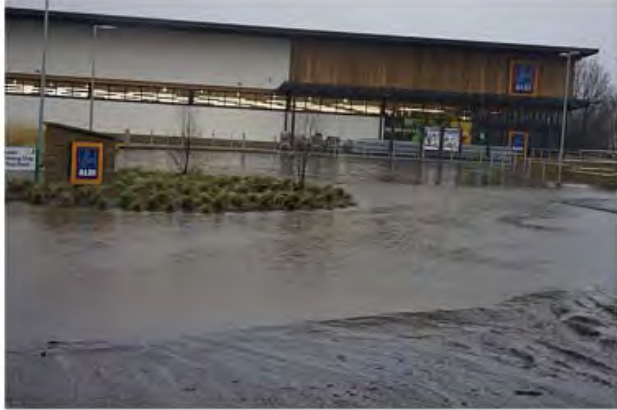
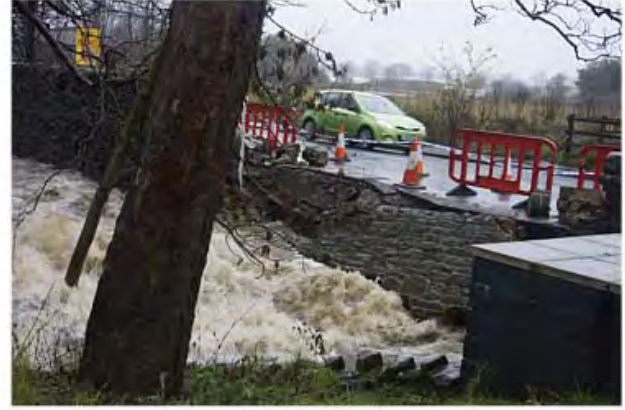
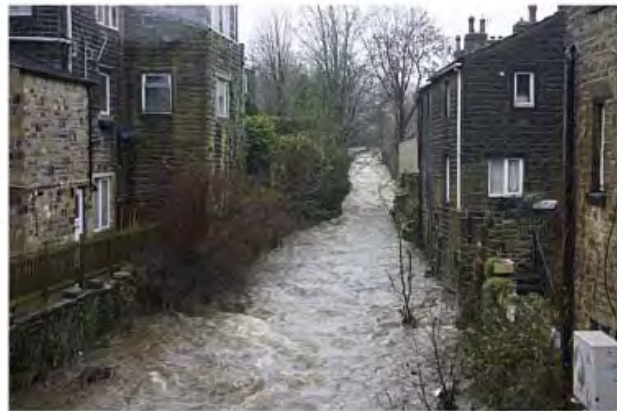
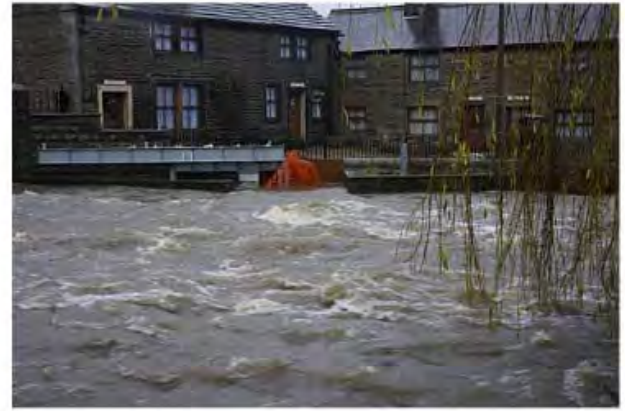
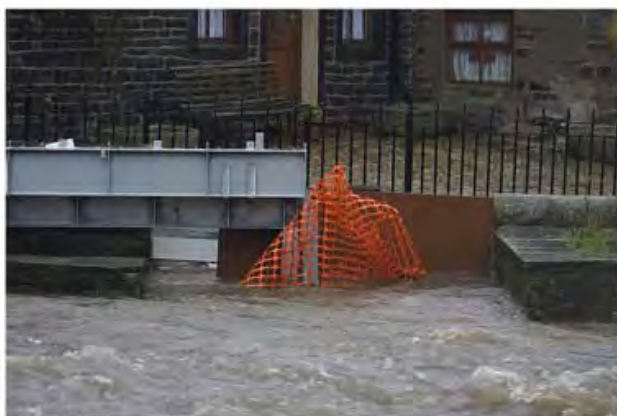
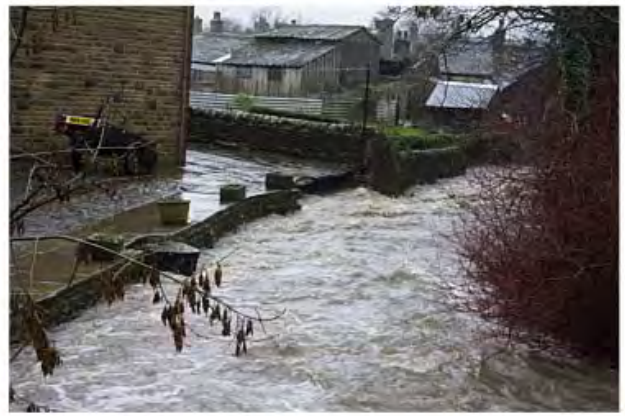
Floods along Keighley Road - Silsden Beck, Boxing Day 2016

The wall by the entrance to Aldi has collapsed with part of the pavement – This collapse could have been exacerbated by the excavation to lay pipes along by the wall. The pipes can be seen exposed on the beck side and I can only assume they are still intact or we would be complaining about the lack of services by now!

The Bridge to the north of Marsel House – this has partially collapsed and will restrict the flow of water in the event of another flood. It has also made the pavement very uneven.

Belton Road Culvert – this is still causing Belton Road to flood. Although a lot of work has been carried out just before the culvert the fact remains the culvert is not of large enough capacity to take the beck in flood. The water from the beck overtops and creates a large lake on Belton Road, there is evidence of this happening from the large pieces of wood above the entrance to the culvert. (If the lake on Belton Road gets large enough the water drains through the gate into the field).

Large Puddles on Keighley Road – there were two very large puddles on the west side Keighley Road (down from the golf driving range). They could have been caused by a blocked drain but I know one always occurs every time there is heavy rain. The cause of these puddles should be investigated.

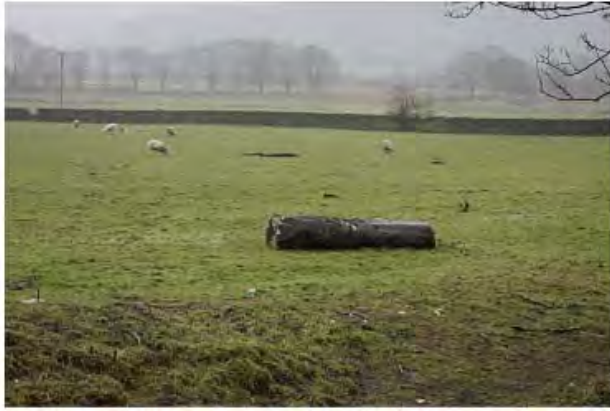
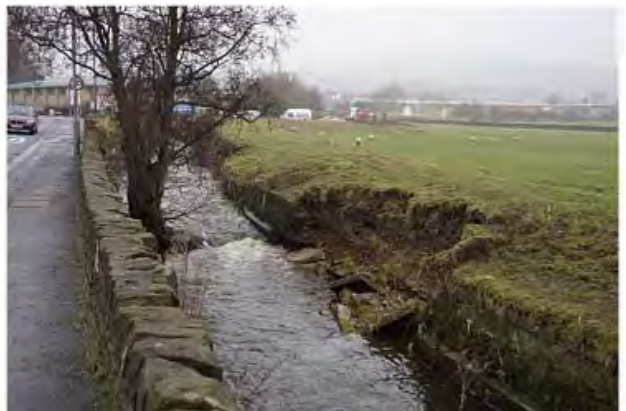
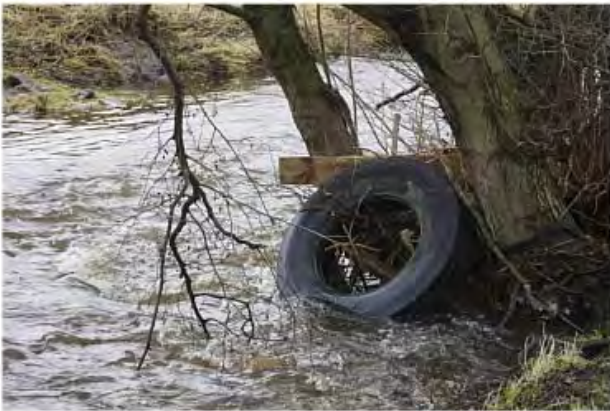
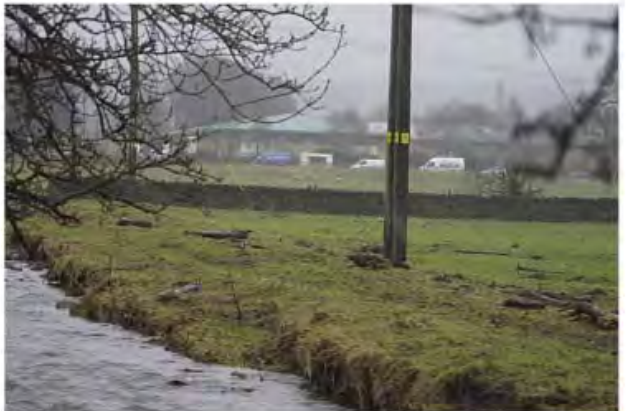
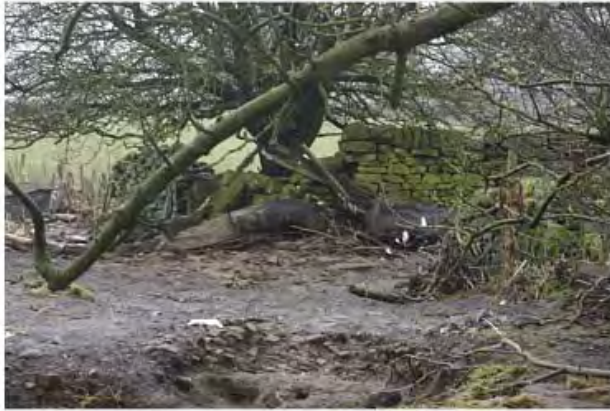
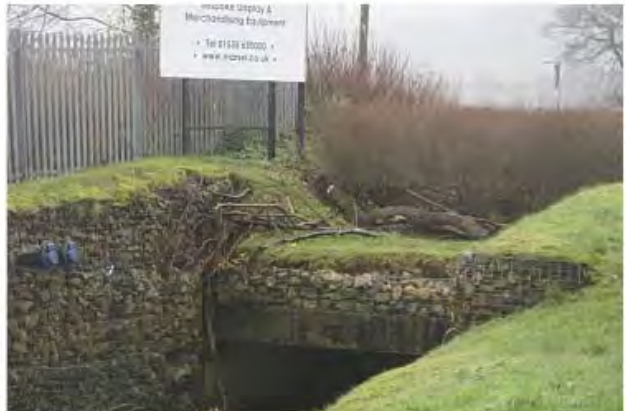
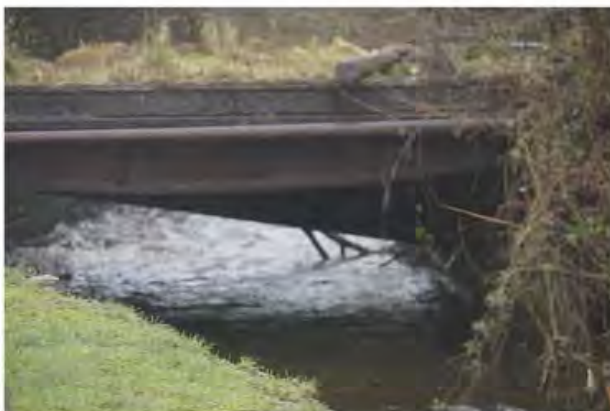
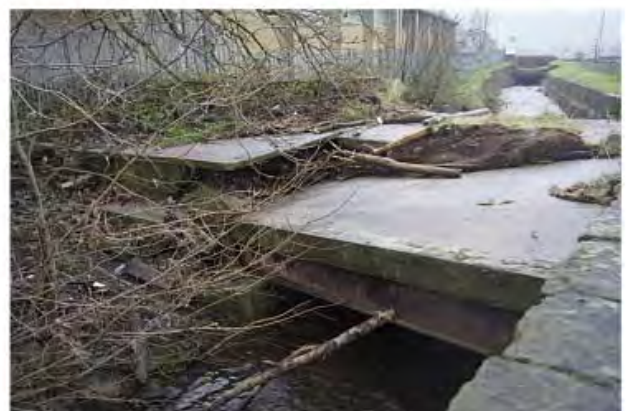
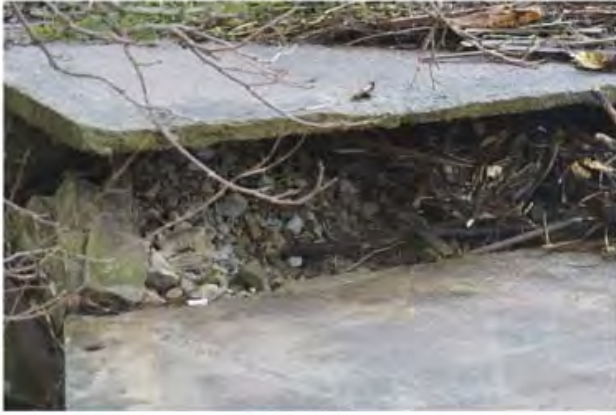
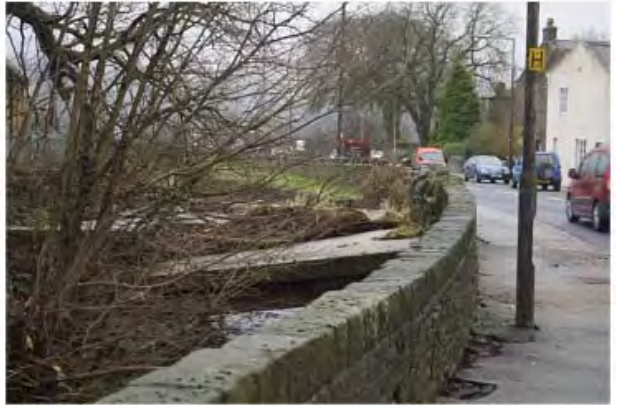
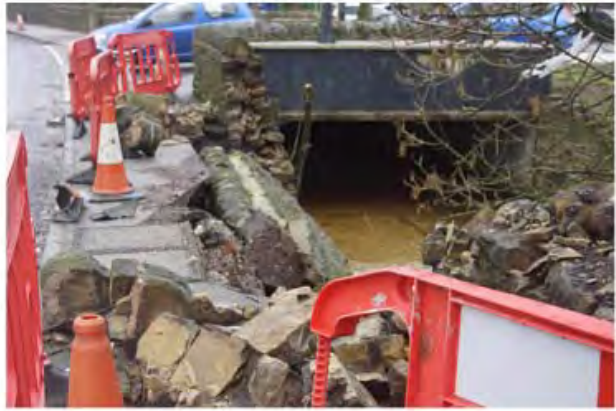
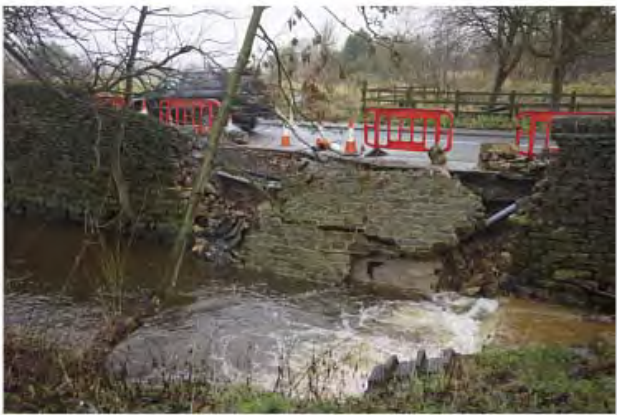
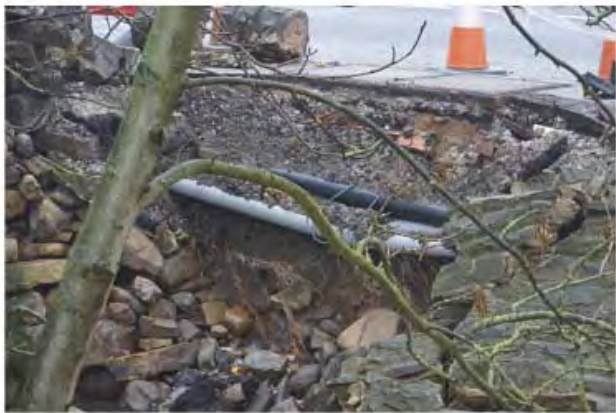
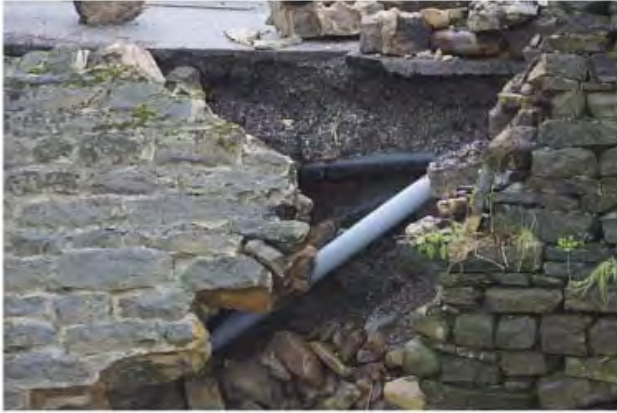
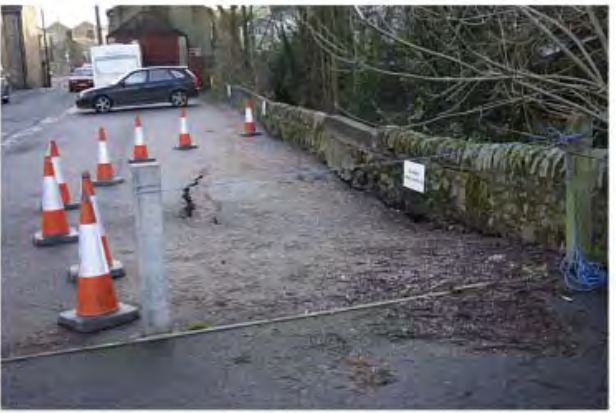
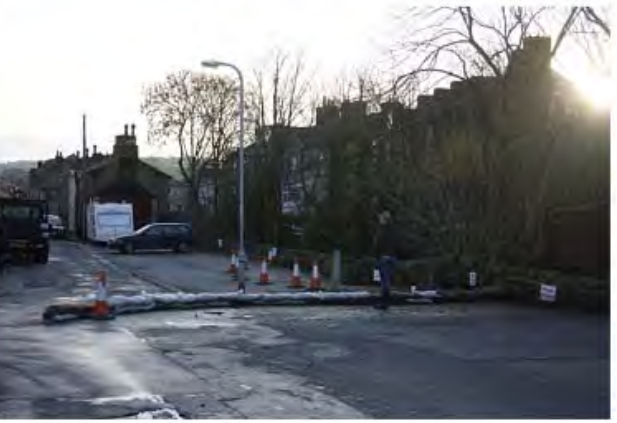
The Damage

The Parking Area next to the beck in St Johns Street - A large crack has appeared possibly caused by surface flooding undermining the area.

This flood caused damage to the walls and banks of the beck. There isn't usually damage to the beck bounds, however the flood was high and the ground was saturated. There were a few very large logs washed down, these were not freshly cut and the branches had been removed i.e. they were logged.

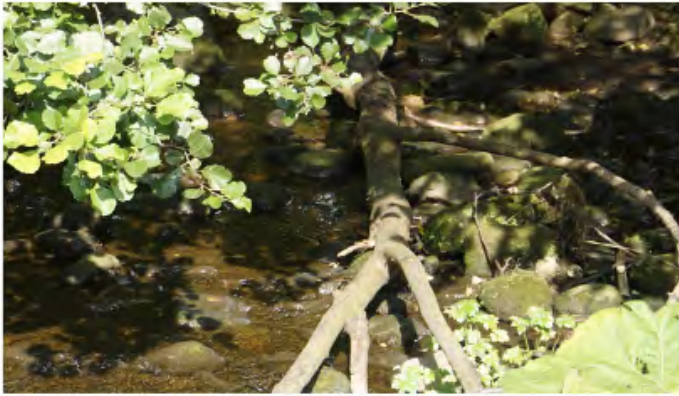
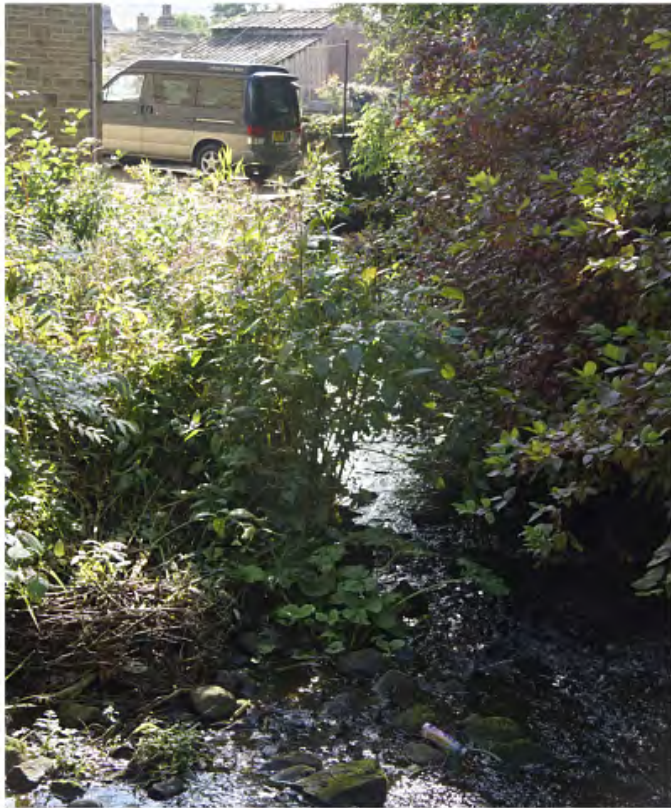
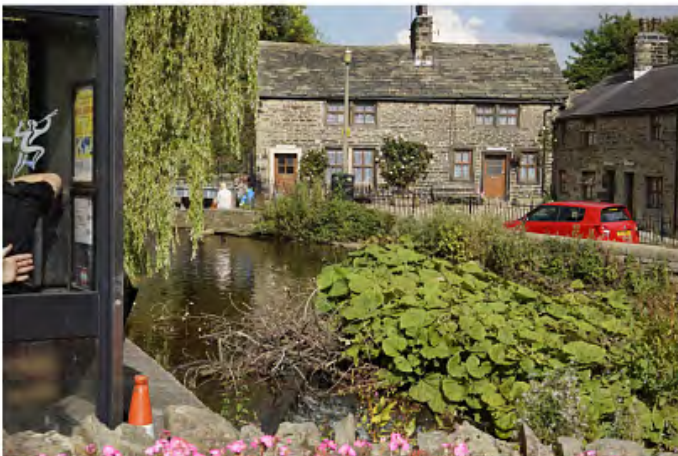
18 Sept 2015

A little preventative maintenance perhaps?

Reported at STC meeting 8 Oct 2015 (item 11)

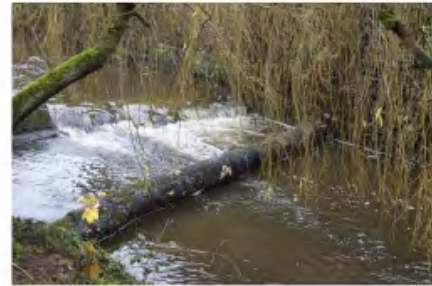
Log from Upstream

The log removed from the beck, just above the Post Office Bridge, by local residents just before the 26 Dec flood, was over 6m in length. Had this log hit the central pier of the bridge it would have probably demolished it!

Removed by local residents 16 Dec 2015
